Transportation Safety Board
of Canada

TRANSPORTATION SAFETY

Issue 20 – Winter 2004

**Derailments, collisions
and dangerous goods**

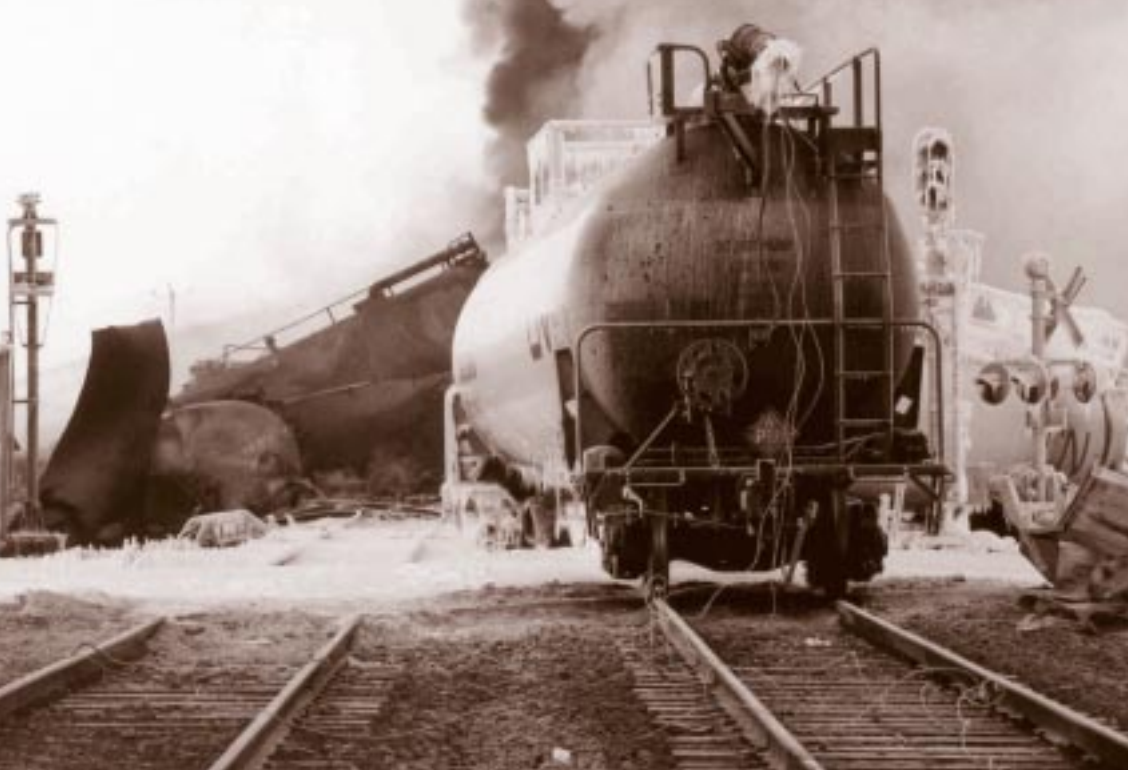
As a result of the derailment, dangerous goods spilled. Most of the dangerous goods burned in the fire and some had to be transferred

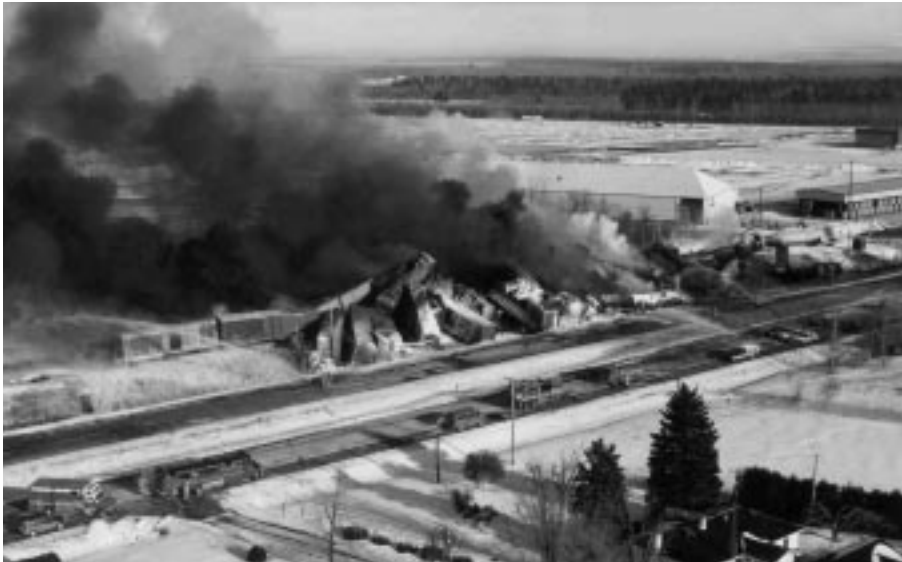
Wreckage from the derailment was spread over a wide area

The investigation determined that train 783 derailed when the south rail of the north track broke at a thermite weld which had an existing pre-crack. Since little damage from wheel pounding was observed on the fracture surfaces of the weld, it was concluded that the fracture was very recent and that the head section of the thermite weld separated shortly before the derailment. In all probability, the 15th car derailed when the rail head section separated.

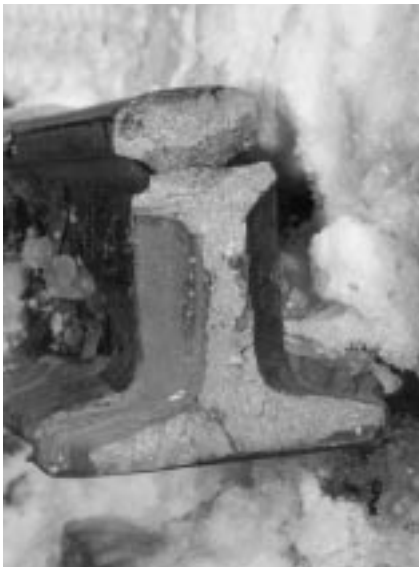
The head section of the thermite weld separated shortly before the derailment.

by a drop in temperature, and residual welding stresses were present at the point of fracture. For the temperature at the time of the accident (-11°C), an impact load in excess of 100 000 pounds would have been sufficient to break the weld at the existing pre-crack. Such impact loads are common.

Thermite welding is a process prone to human error; a weld execution requires 13 distinct steps that must be performed in a precise order by a well-trained operator. Moreover, defects located in the base of the weld cannot be detected by automatic inspection methods, and the probability of detecting cracks at the time they emerge in the web is relatively minimal because, once started, this type of crack propagates rapidly. Without an ultrasonic inspection of the entire periphery of the weld and quality control by independent personnel, inappropriate materials or work procedures, which can lead to defective field welds, cannot be identified. Welds are critical elements of the track infrastructure and as such need particular attention.

The rail fractured at a thermite weld

Transport Canada review the requirements for the inspection and quality control of thermite welds to ensure that an adequate level of safety is maintained on all types of tracks.

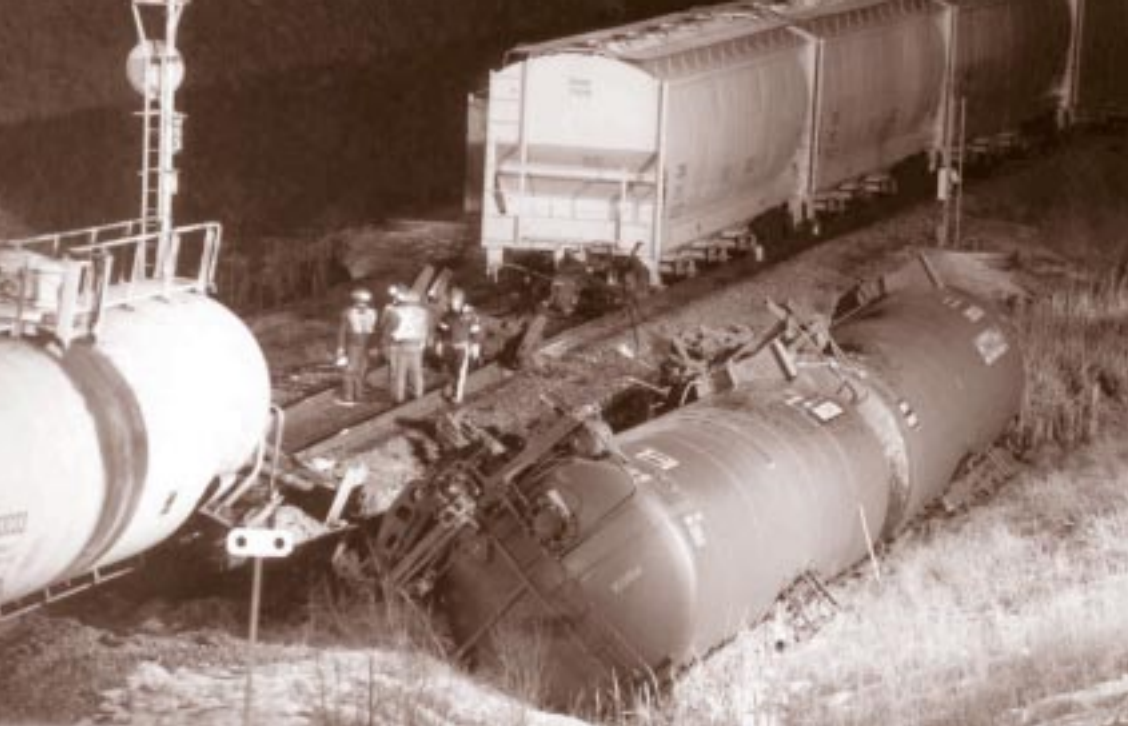
**Derailed tank cars
overturned and
resting in ditch**

More than 71 tonnes of anhydrous ammonia were spilled into the atmosphere from an overturned tank car after a derailment in Red Deer, Alberta, on 02 February 2001. Approximately 1300 local residents and businesses were evacuated, and 34 persons were treated at the Red Deer Hospital and released. One person who was overcome by the vapours while crossing the railway right-of-way later died in hospital.

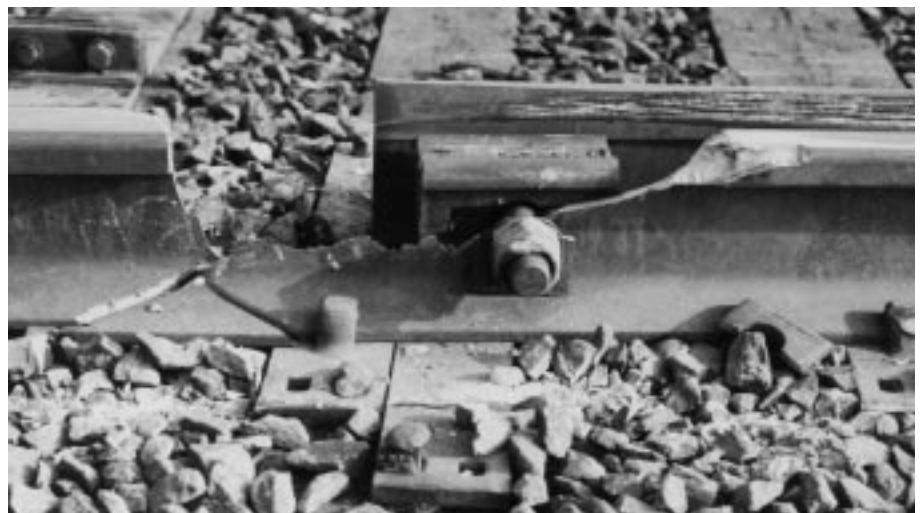
The broken rail at the point of divergence

The bolt hole in the web of the rail had significant long-term damage caused by the bolt rubbing against the hole, indicating that, at some point in time, the bolt had not been adequately tightened. Because the nut of the bolt on the field side of the rail and a spacer block on the gauge side completely concealed the bolt hole, visual turnout inspections did not detect the damage. Monthly visual turnout inspections and detailed semi-annual turnout inspections, as outlined in CPR's Standard Practice Circulars – Track (SPC) No. 33 (effective 01 April 2000), may not be adequate to ensure the detection of damage to bolt holes in high-risk sections of the track.

The damage to the bolt holes caused two pre-cracks to form in the rail. Their location was such that they too would not have been detected during the

monthly turnout inspections. Both pre-cracks were large enough to reduce the strength of the rail to such an extent that the lateral stresses caused by the derailed car hitting the frog were great enough to fracture the rail.

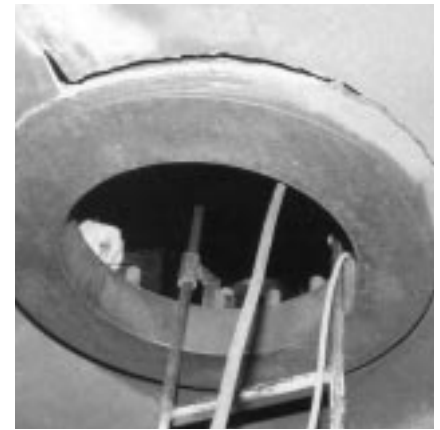
The tank car that discharged the anhydrous ammonia had three shallow pre-cracks on the surface of the manway plate. It is likely that these were formed as a result of thermal stresses induced by the welding of the manway nozzle to the shell of the tank at the time of construction in 1968. While pre-cracks may exist for many years without compromising the integrity of the plate under normal operating conditions, a brittle failure may occur when the pre-cracks are exposed to abnormally high stress levels at low ambient temperatures. In this incident, the stresses caused by the impact to the manway nozzle when the derailed car overturned exceeded the structural design capabilities of the tank, resulting in a brittle fracture

Pre-cracks on the surface of the manway plate

and the gradual release of ammonia.

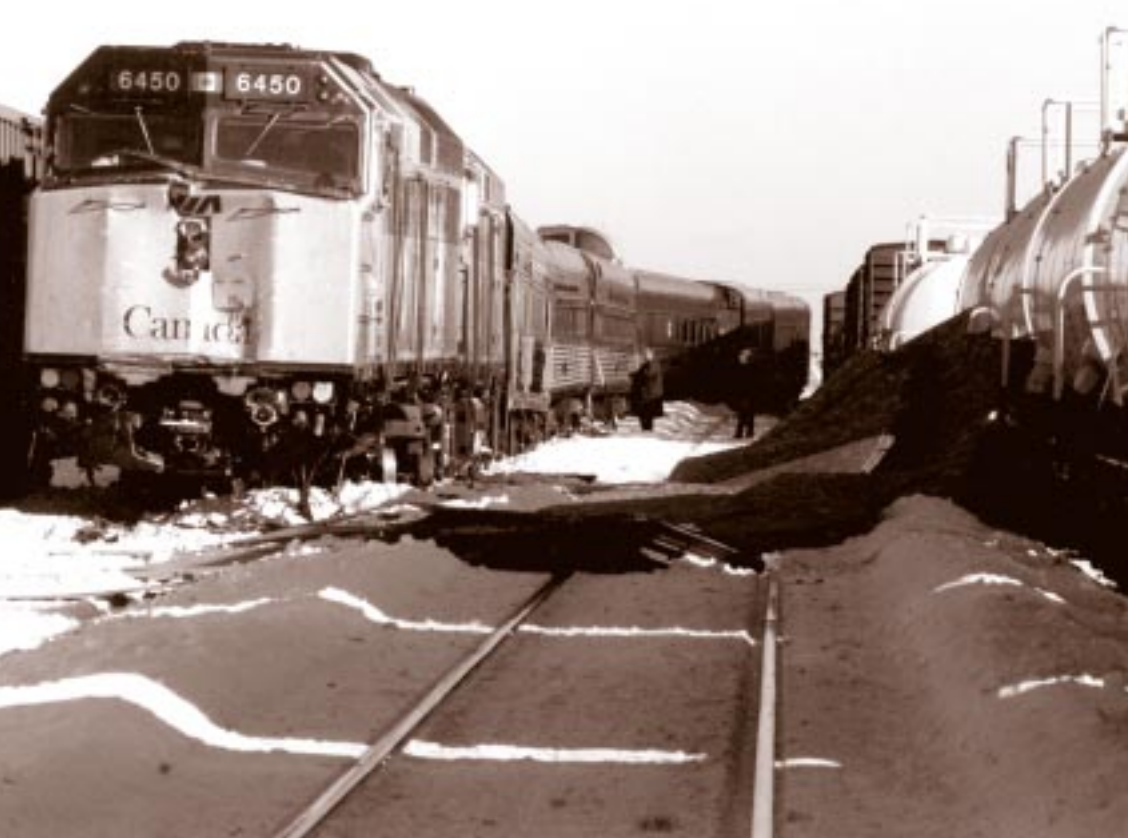
Some of the damage to lead locomotive VIA 6450. Note displaced front truck under centre of locomotive (which damaged the battery boxes and diesel fuel tank) and impact marks on collision posts on the front of the locomotive. (Source: *Miramichi Leader* newspaper)

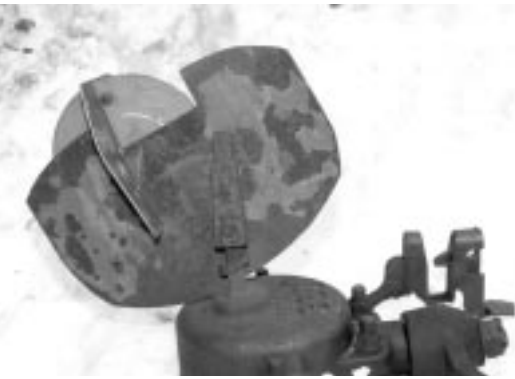
The locomotive engineer was vigilant to train operation, but the poor condition of the switch target, tip assembly, and mast prevented the misaligned main-track crossover switch from being detected from a distance sufficient to avert the collision. — Report No. R00M0007

The switch stand at Mile 65.1, a 36-D low, rigid type, did not meet specifications. The mast extension was 12 inches in length, not 25 inches as stipulated. It was fractured in two pieces, one seven inches long, the other five inches long. Construction was of forged steel with a cross-section measuring about 3/4 inch square

Switch target and tip assembly from 36-D switch at the main-track crossover at Mile 65.1 immediately after the accident, as viewed in the direction of travel by the VIA train crew

with an integral one-inch-square socket and set screw. It conformed to a Canadian National (CN) specification for a part to be used in a target tip assembly for forged switch masts, and was not designed for use with a large target switch. It was not painted black and was completely rusted, including the fracture surfaces.

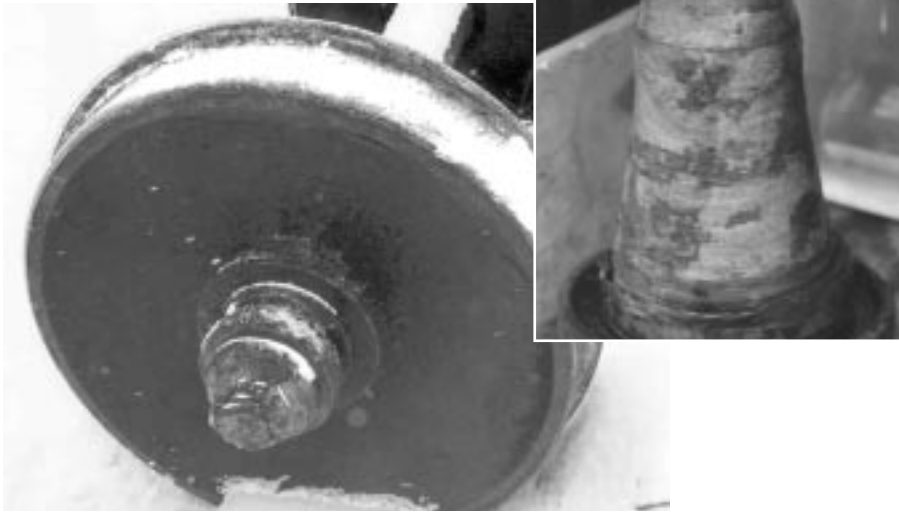
An examination of the derailed rolling stock determined that a burnt-off journal at the No. 2 wheel on the 27th car had occurred. Just prior to the derailment, the roller bearing overheated and seized. The axle then extruded, resulting in a reduction of cross-sectional thickness. After sufficient thinning, the overheated axle could no longer support the weight of the car, leading to a complete axle failure. Based on derailment marks on the track, it

Burnt-off journal and wheel assembly from car SOO 18748

was determined that the axle failed approximately 3800 feet east of the scanner located at Mile 82.1. The cause of the overheated bearing could not be determined.

Subsequent to this occurrence, CPR modified the software on all wayside detectors such that, while passing the detector, the alarm tone is immediately followed by a radio announcement identifying the nature of the defect (e.g. dragging equipment, hot box or hot wheel).

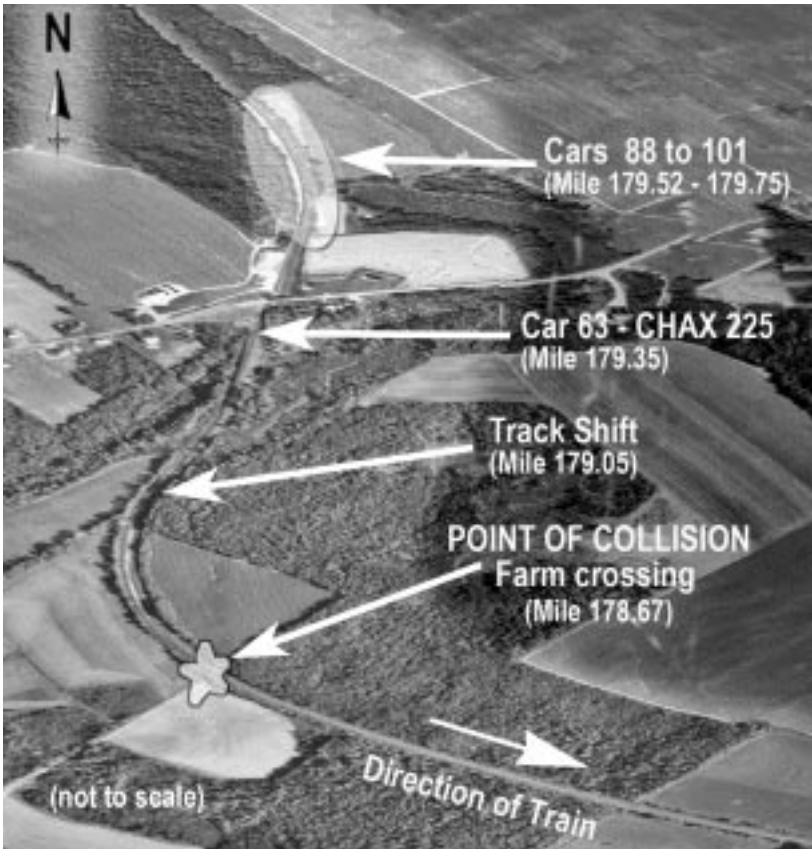
One of those accidents occurred on 06 October 2001, when Canadian National (CN) freight train No. M-306-31-05 (train 306) derailed 15 cars after striking a stalled automobile at a farm crossing at Mile 178.67 of the Napadogan Subdivision in Drummond, New Brunswick. The three occupants had evacuated the automobile before the collision and were not physically injured. One of the tank cars suffered damage to the top protective housing and fittings, causing a release of butane.

Aerial photo of accident site (Source: Natural Resources Canada)
